Building Bush on Cloverbrook

CASE STUDY

BUILDING BUSH ON CLOVERBROOK

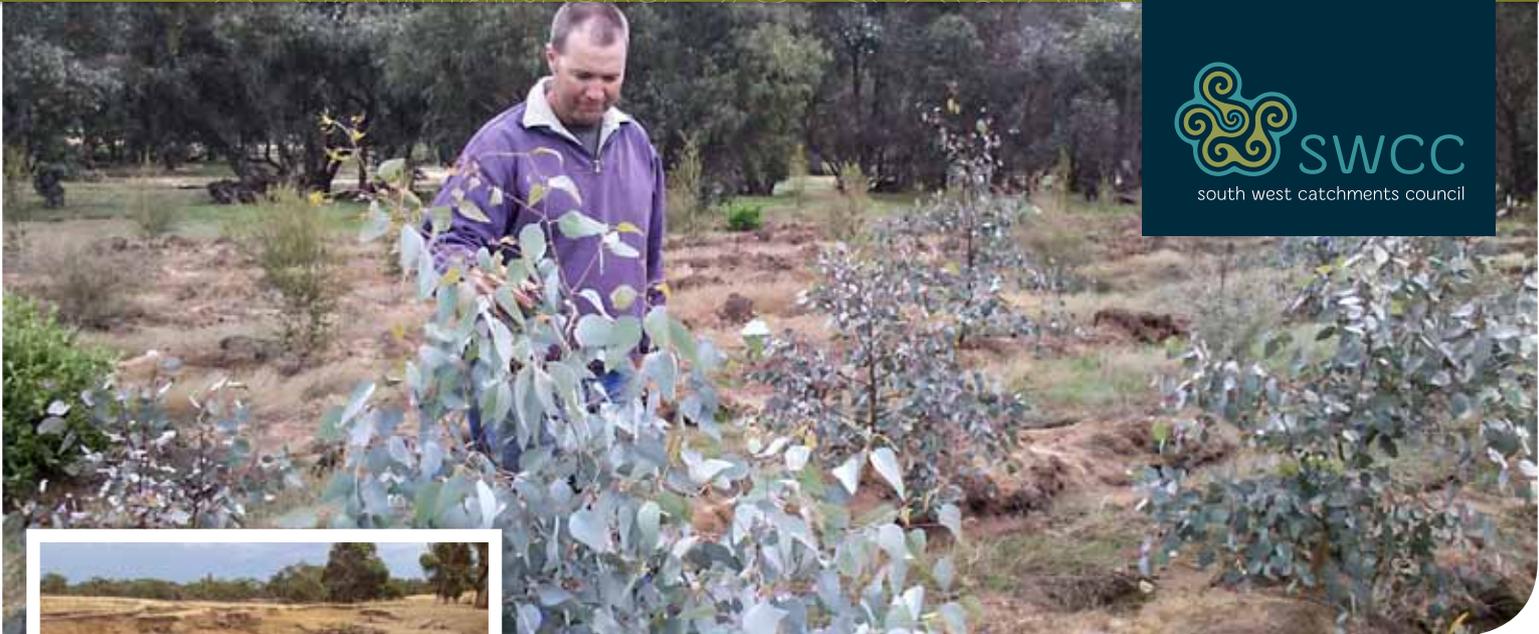
ABOVE: Geoff Hillman with successful revegetation at Site 1 in May 2013. (photo: Terry Brooks)

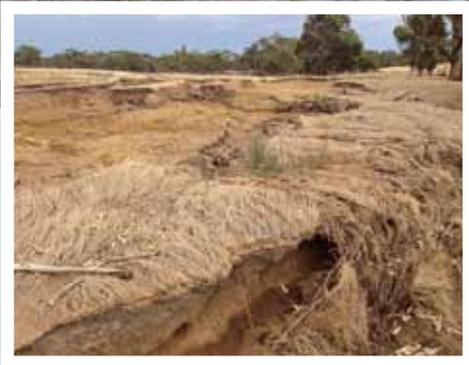
INSERT: Riparian flood fringe with severe erosion as result of large magnitude flood event in December 20 (photo: Terry Brooks taken February 2013)

However, a fallen tree across the waterway was an issue, as the floodwaters flowed through and damaged a section mounded in preparation for the 2013 planting season. The floodwaters gouged out waist-deep gullies, making it difficult for machinery to access the area. Geoff plans to continue with his planting program in 2013 although some flood-affected sections may be difficult to establish.

The project results highlight the fact that the first year of establishment is when revegetation is most vulnerable to what nature throws at it. In this instance it was flood. Mounding on a level contour or herringbone design (rather than parallel to the waterway) could possibly have reduced the impact of floodwater erosion, and the timing for doing site preparation for

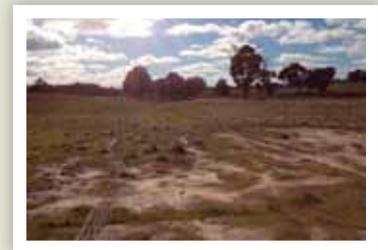
TOP INSERT: Degraded riparian zone at Site 1 in July 2012 (photo: Terry Brooks)

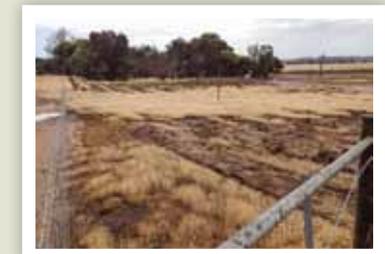
BOTTOM INSERT: Site 1 fenced, ripped and revegetated in February 2013. Note barley grass area in middle of photo not revegetated due to high level of waterlogging/salinity (photo: Terry Brooks)
